News from the Repair, Evaluation, Maintenance,
and Rehabilitation Research Program

Volume 10, Number 4

December 1993

Geomembranes for repair of concrete hydraulic structures

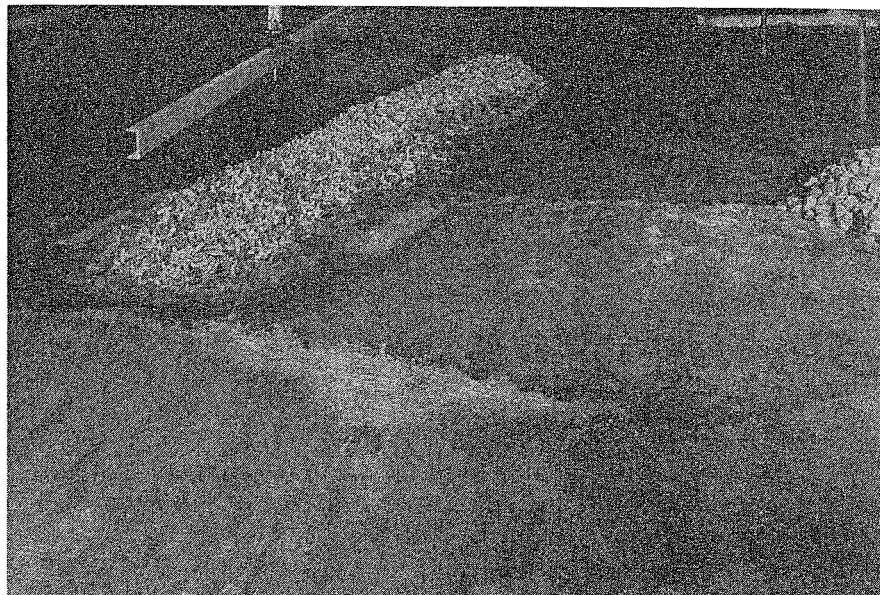
Figure 4. Toe stability tests

structure position and shape with the waves and currents. A photograph of the test section is shown in Figure 4.
